National Transportation Safety Board Aviation Accident Final Report

Location:	SAVANNAH, GA	Accident Number:	ERA16LA082
Date & Time:	01/06/2016, 0835 EST	Registration:	N978AF
Aircraft:	PILATUS AIRCRAFT LTD PC-12	Aircraft Damage:	Substantial
Defining Event:	Flight instrument malf/fail	Injuries:	2 Minor
Flight Conducted Under:	Part 91: General Aviation - Positioning

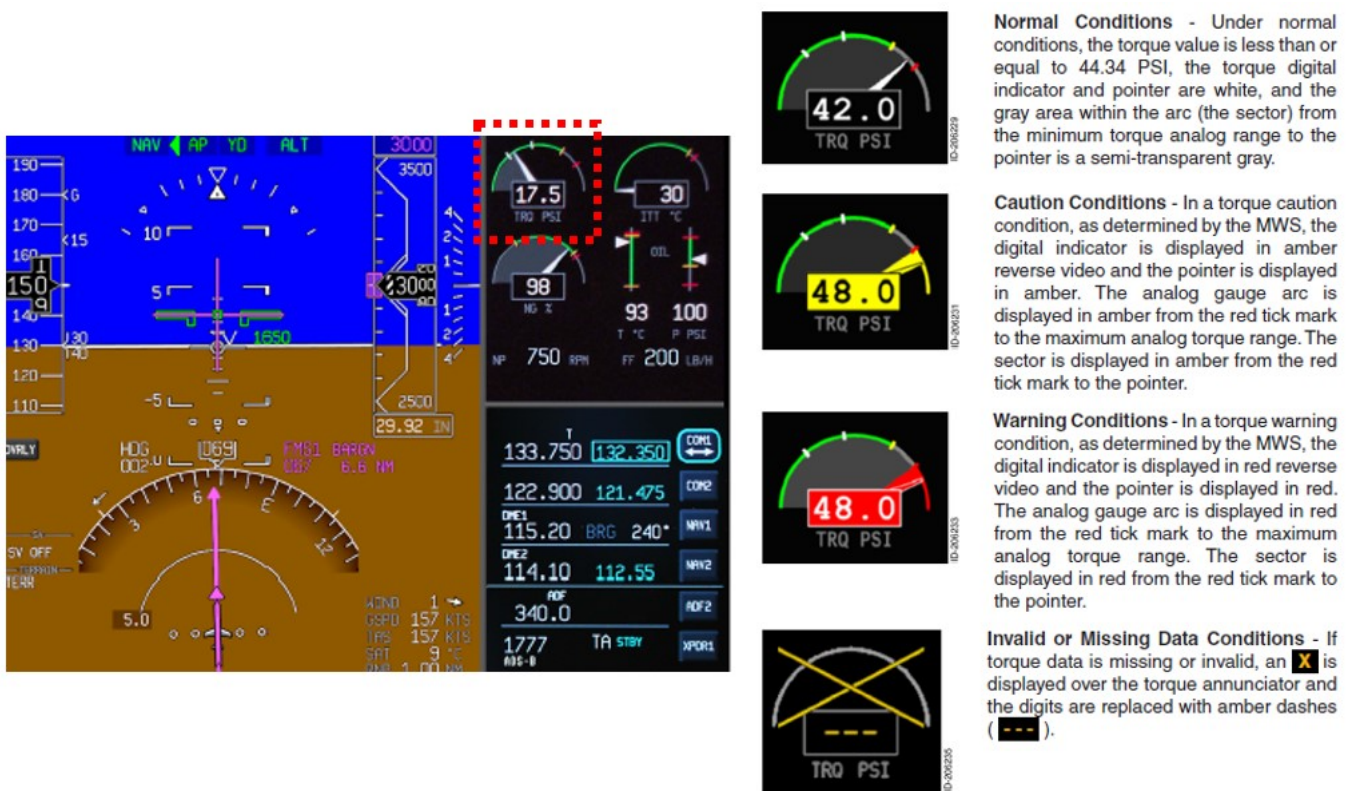
The torque and engine temperature indications in the cockpit were depicted with pointer-type display gauges and digital values (see figure 1). During normal operations, all digital values were displayed in white against a black background. The torque analog scale range was from 0 to 55 psi and the digital scale range was from 0 to 70 psi. Two white torque tick marks were on the analog scale at 15 psi and 25 psi. An amber tick mark at 36.95 psi indicated maximum climb/cruise torque, and a red tick mark at 44.34 psi indicated maximum continuous torque. A green arc on the torque gauge from 0 psi to the amber tick mark indicated normal operating torque range and beyond the amber tick mark, the gray arc is the maximum torque range. When the excessive torque warning occurred, the digital indicator and pointer were displayed in red with the associated CAS message. There were no associated CAS messages for low torque values, only high torque exceedances activated a CAS caution or warning.

Figure 1. Primary Flight Display (PFD) and engine instruments window showing torque conditions examples.
