“I wonder what will happen when I...”

Operate the Flap Interrupt Switch

By John Morris

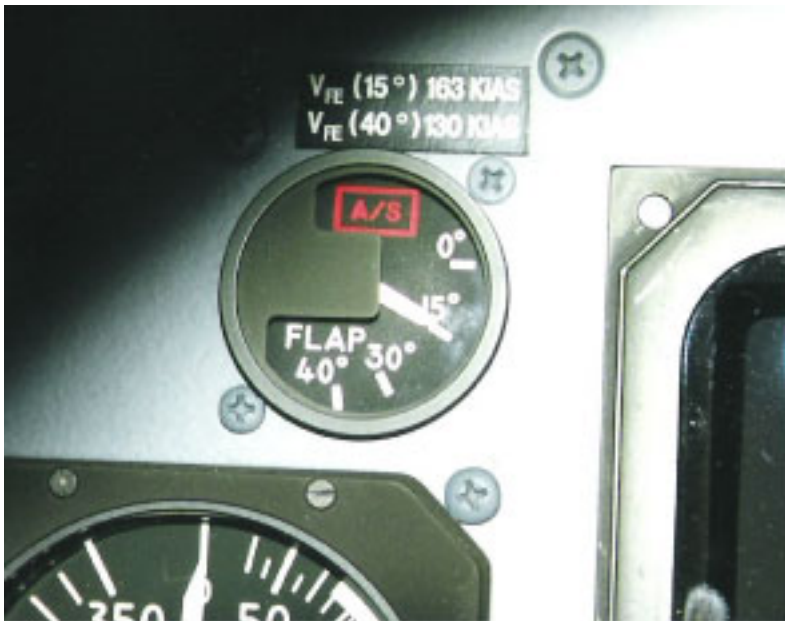
Overspeed indicator MSN 101-888

Lastly, the Flaps, Actuators and Flex cables are now inspected annually (used to be more frequent until improvements matured). Maintenance is checking for out of tolerance movement in the actuators and cables possibly caused by normal and overspeed stress, as well as panel deformity. Pilatus installed a Flap overspeed visual annunciator (in the Flap indicator MSN 101-888) and aural tone to alert us to this, NG aircraft have multiple indications on the PFD and a voice callout.

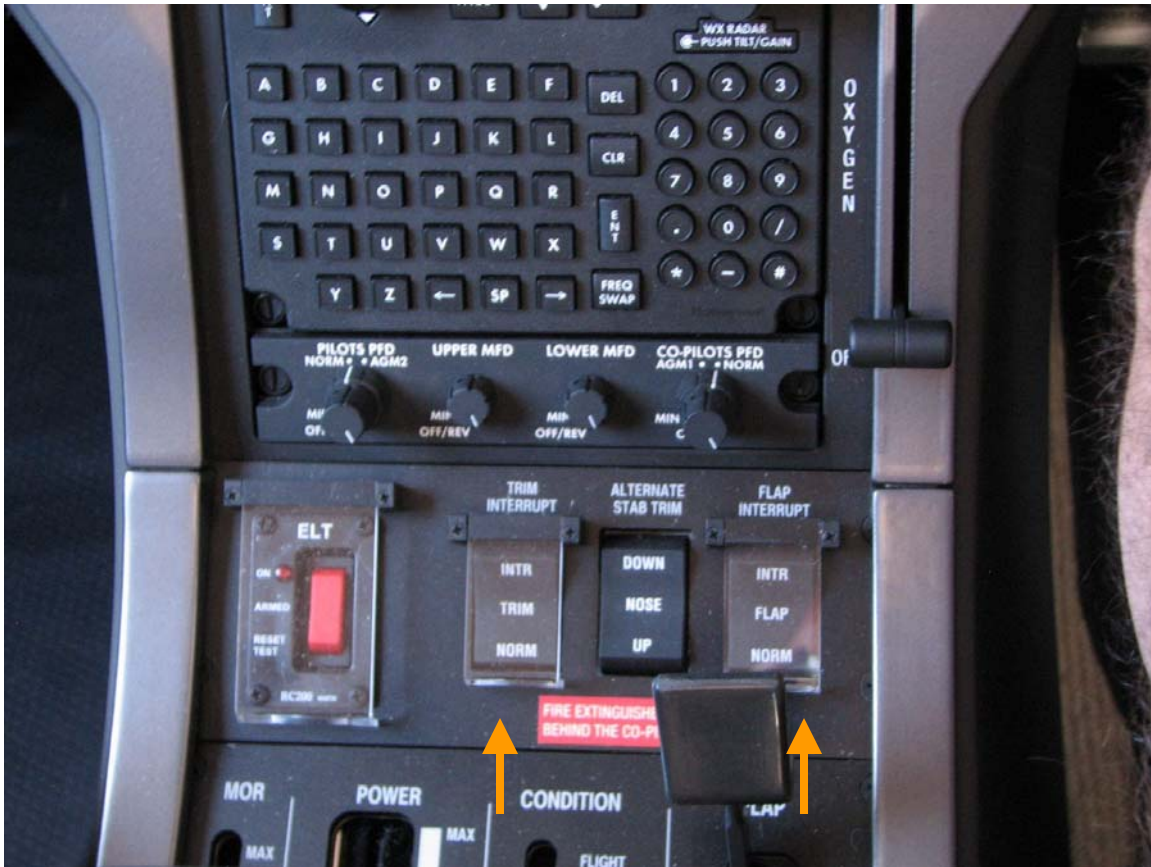
PC12 NG

Note: Trim Interrupt/Flap Interrupt Positions and Alternate Stab Trim

To answer these questions I want to first give you some history of the PC 12 Flap System and its design. When the PC 12 first entered production it had the TRIM and FLAP Interrupt switches on the center console, left side (see pictures). These
